# Fangstkontroll og fiskevelferd i ringnotfiske etter sild

**MS «Eros» 12.–19. juni 2018**

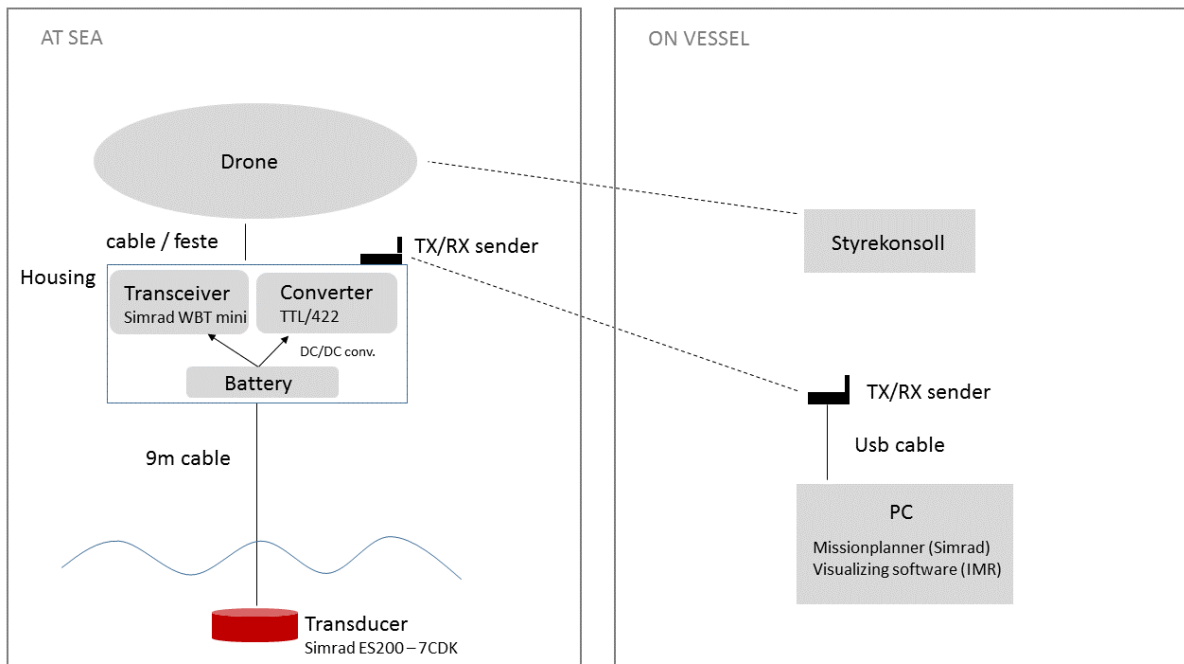
**Figur 1.1.** System diagram

Transceiver var montert i en Peli-case box sammen med batteri og omformer og festet til dronen (Figur 1.1 og 1.2a). Transducer hang i en 9 m lang kabel og ble senket i vannet ved hjelp av den flyvende dronen og kunne da måle fiskestimer. WBT mini ble operert fra en PC på båten via et radiomodem (Figur 1.2b). Det var da mulig å starte/stoppe pinging og sende komprimerte VBS (volum backscattering) data til båten under operasjonen (Figur 1.2c). I tillegg lagres rådata i minnebrikke festet til transceiver for etter-prosessering (Figur 1.2d). Det var en del problemer med styringen av dronen på grunn av forstyrrelser i magnetfeltet som igjen påvirket kompasset. Dronepilotene gikk over på delvis manuell styring og da gikk styring av drone relativt bra. Flytiden var kun på ca. 15 minutter og dronen er følsom for vind og regn. I fremtiden vil det være behov for å utvikle / bruke en annen type drone. Sildestimene var små og vanskelige å treffe med dronen, men vi fikk en del målinger av fisk som ble visualisert i sanntid og lagret (Figur 1.2c og d). Sonar på egen og andres båter ga imidlertid en del støy på ekkoloddet på dronen.

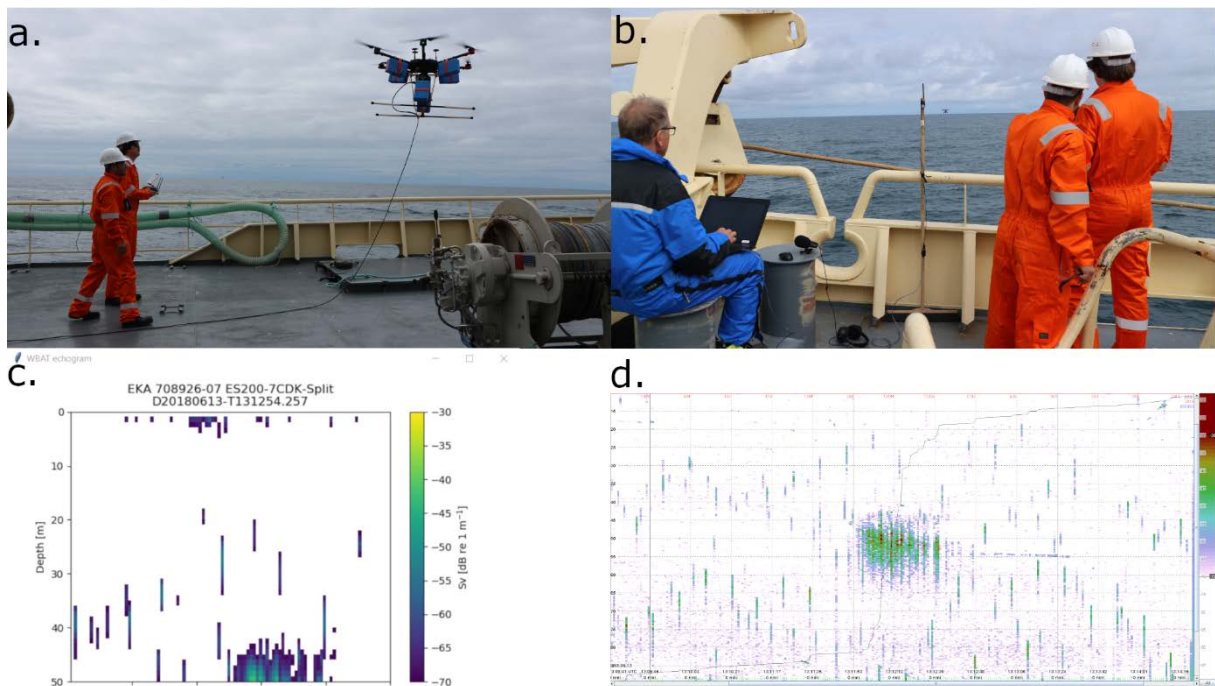
**Figur 1.2.** Birdview AS opererer flyvende drone med ekkolodd (Simrad ES200 – 7CDK transducer og WBT mini transceiver) (a). Data blir overført fra drone til pc gjennom radiolink (b). Dataene blir visualisert med et program skrevet av Gavin Macaulay, HI (c). Rådata lagret i instrumentboksen under dronen etterprosesseres i lss (d).

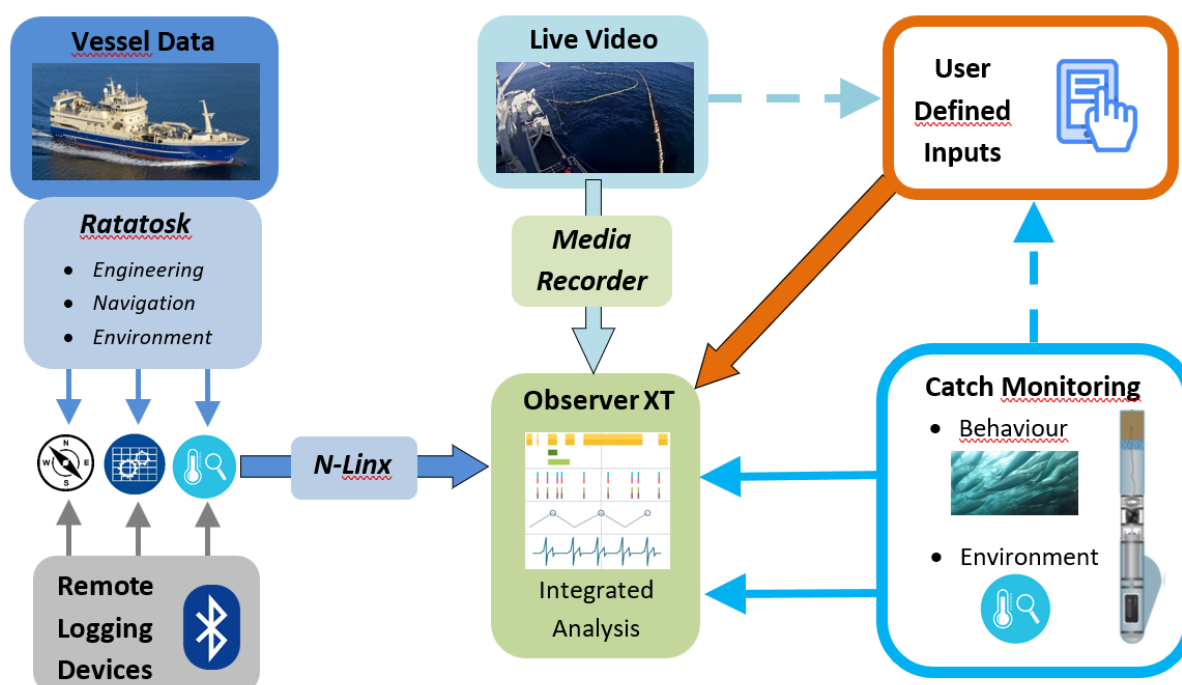
**Figure 2.1.** An overview of the compilation and integration of data (behavioural, engineering, environmental, and navigational) from several sources (vessel, live video, remote logging devices, catch monitoring devices and user defined inputs) via the Ratatosk, N-Linx, Media Recorder and Observer XT systems.

I tillegg til maskineri, navigasjon og miljødata logget med Ratatosk, blir mange andre data kilder kompilert og lagret i NOLDUS Observer XT software, blant annet sanntidsvideo av fiskeprosessen, og atferds- og miljødata fra fangstovervåkingsprobe. Kompilerte og tidssynkroniserte data kan så brukes til integrerte analyser om fiskeatferd under fangst (Figur 2.1).

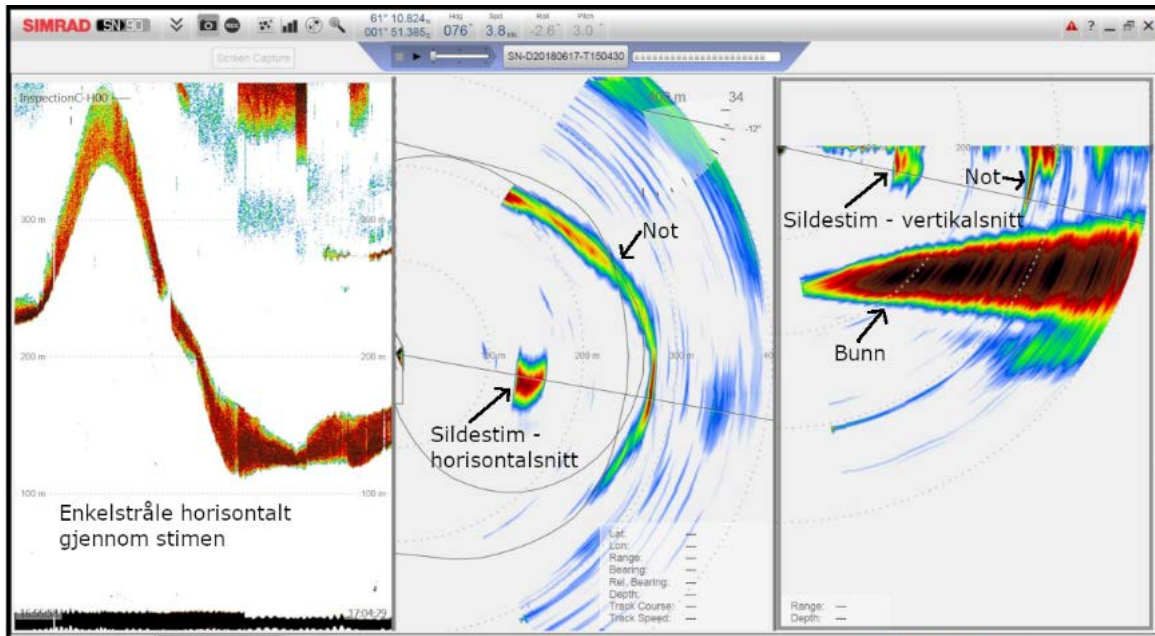
**Figur 3.1.** Skjermdump fra SN90-sonaren. Et snitt gjennom stimen kan ses vertikalt og horisontalt. I tillegg vises data fra en enkel stråle gjennom stimen som et ekkogram. Stim xx under utsetting (a) og innhaling av not (b).

Stimenes atferd og reaksjon til fangst ble overvåket med Simrad SN90 sonar før og under fangst (Figur 3.1). Før fangst og under utsetning av not var dataene bra. Under snurping mistet vi i stort sett signalet fra stimen, unntatt i de største fangstene der vi til tider hadde gode data også under snurping. Under innhaling av not varierte kvaliteten på dataene. Stimene gikk ofte inn i notveggen lengst unna båten, og da var det ikke mulig å skille stimen fra nota. Notveggen var

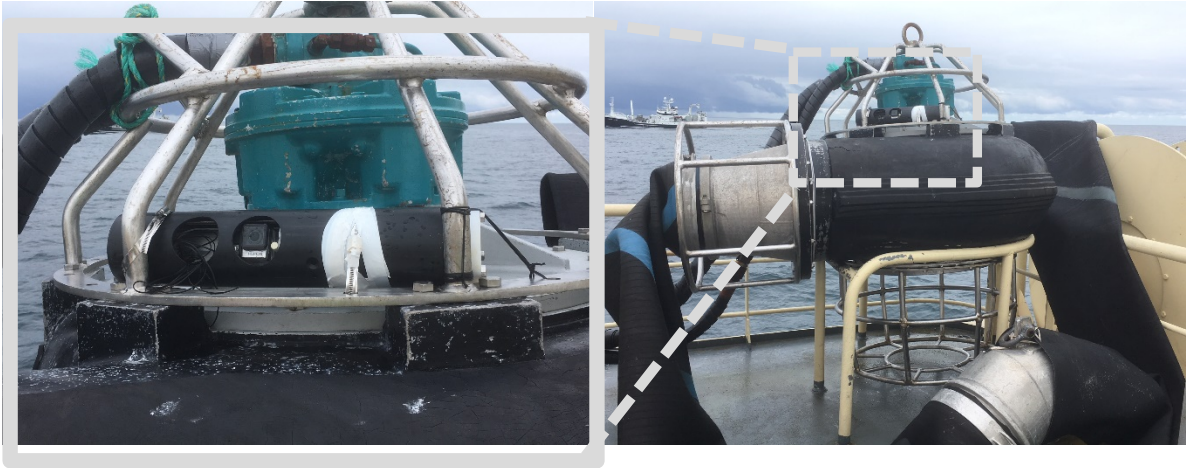
**Figure 4.1.** The Catch Monitoring Probe fitted to the catch pump.

To monitor and characterise the catch (with respect to species composition, individual size distribution and behaviour), as well as describe environmental conditions in the net (i.e. temperature and dissolved oxygen concentrations), IMR/HI is developing the Catch Monitoring Probe (CMP). This system comprises several different instruments, including: a pneumatic canon (for deploying the probe into the catch); a shock proof housing (to protect, support and stabilise the instruments during deployment and operation); a Sony 360 Camera (for complete contextual views around the probe); a Weeview SID stereo camera (for making 3D measurements inside the catch, including fish size); RINKO ID oxygen, temperature & depth logger; and compass and tilt sensors (for logging the orientation of the probe during operations). In addition to the CMP, a simpler version of the monitoring probe (containing; a RINKO ID oxygen, temperature & depth logger; and GoPro 5 camera) was attached to the vessel's catch pump, to monitor the catch during pumping; where it would be too hazardous to deploy the CMP (figure 4.1).

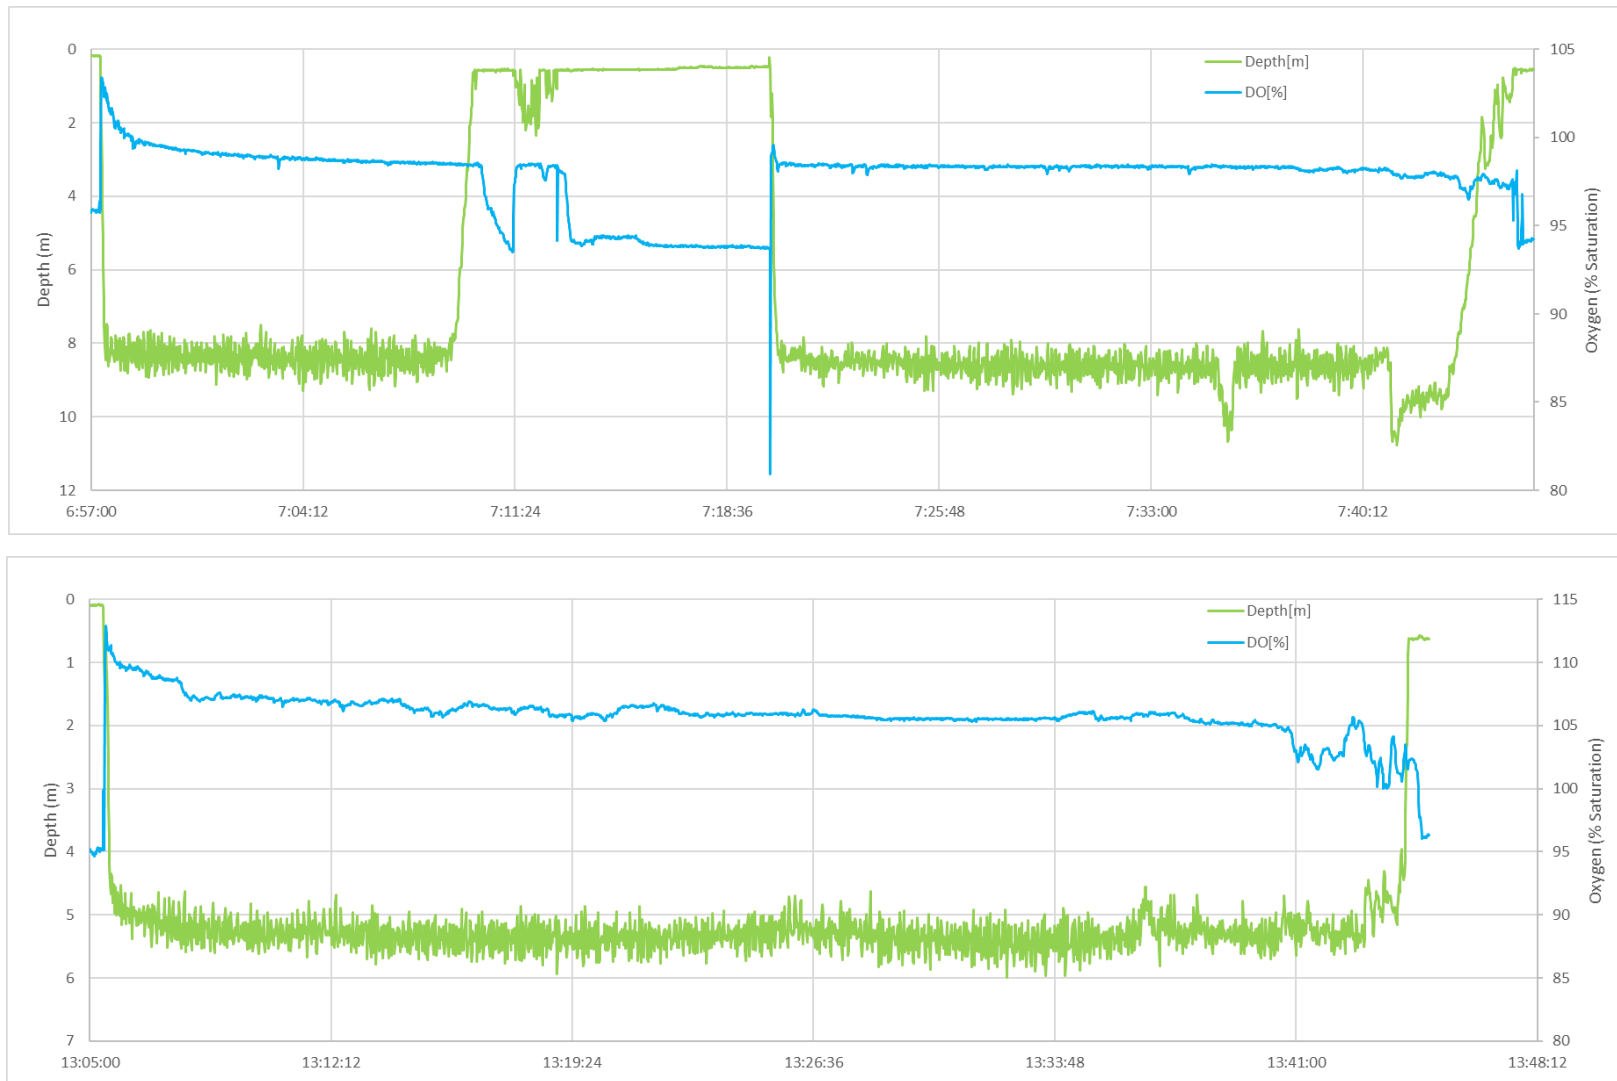
**Figure 4.2.** Examples of oxygen and depth profiles from the catch monitoring probe (CMP); top cast 01 and bottom cast 09.

Preliminary analysis of the data has revealed that during most of the capture process, the small fish schools (max: 36 tonnes) remained relatively uncrowded and free-swimming, with no evidence of any significant hypoxia (figure 4.2). However, during pumping the catch became very crowded and oxygen concentrations as low as 36.6 % saturation (3.67mg/l) (cast 05) were observed.

The new probe housing functioned well, with regards to protecting and stabilising the instruments. However, several issues were identified during the trials that will require further work before the next tokt. Firstly, it was noticed that air was unintentionally being trapped inside the body of the housing, making the submerged half of the probe more buoyant than designed (and therefore unstable). Holes were drilled in the outer casing of the housing, to ensure that the wet sections flooded more quickly. However, preliminary analysis of the oxygen/depth data and video footage has revealed that there is still some air retention for at least the first 5 minutes of the deployment. More importantly, as the air is slowly bubbling out of the housing, it appears to be increasing the localised dissolved oxygen concentration – thus affecting the reliability of the probe oxygen measurements (figure 4.2).

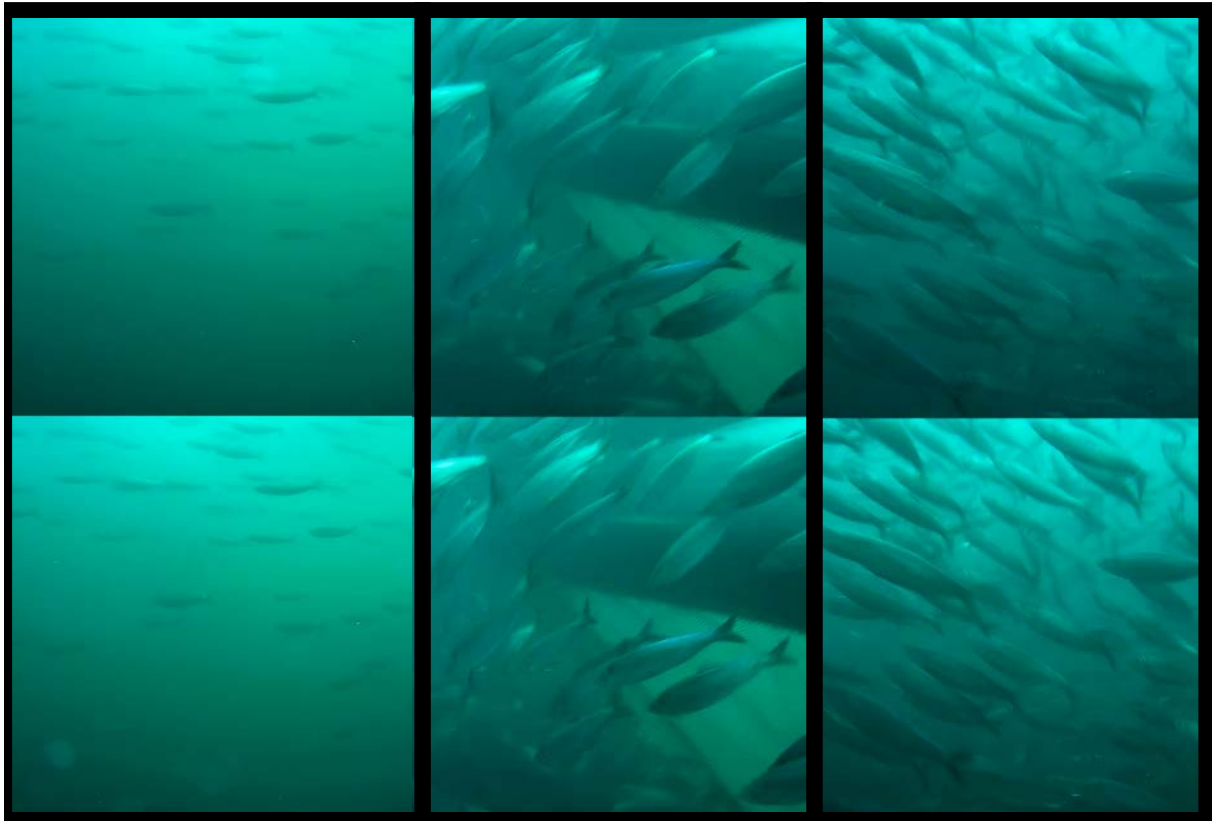
**Figure 4.3.** Paired stereoscopic images from different stages of the capture process.

With regards to the stereo-camera, further analysis is required to determine whether the Weeview SID camera is suitable for catch characterisation. During calibration of the system, it was noticed that distance measurements are inaccurate in the z-dimension (i.e. into the image) due to poor depth of field resolution because of the small distance (5cm) between two camera lenses. Images from this tokt will be used to determine whether measuring fish that are swimming approximately perpendicular to the camera (i.e. with minimal reference to the z-dimension) can be used for accurate mean length/weight characterisation compared to measured catch sub-samples (Figure 4.3). This would be advantageous, because the SID camera has several useful features, including: it is a commercially available product; is light-weight; and outputs a single synchronised video stream of paired images (thus avoiding image synchronisation issues, particularly during live feed transmissions). If not, it will be necessary to develop a new camera system, which has lens separation distances optimised for catch characterisation.

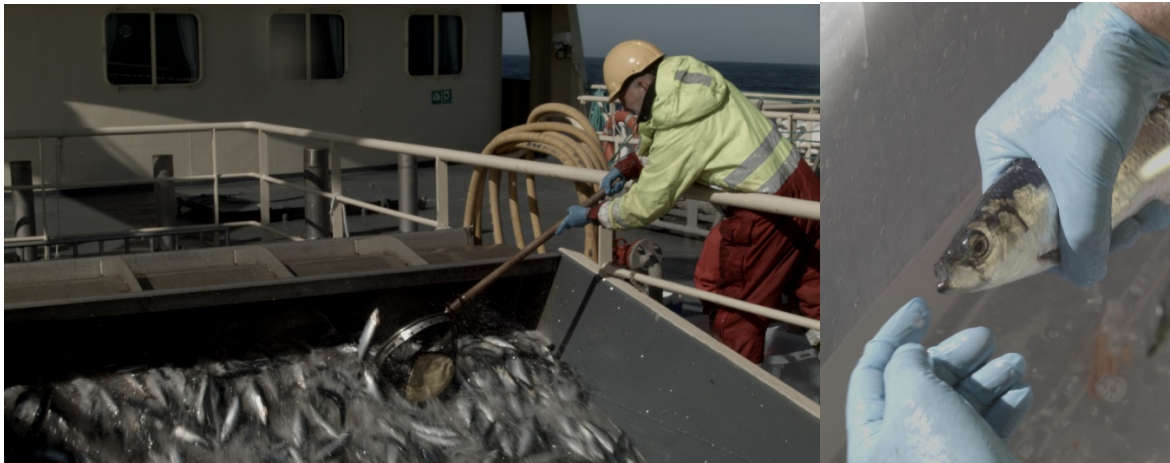
**Figure 5.1.** Left: fish are sub-sampled from the pumped catch for a vitality assessment; and right: a herring is examined for vitality.

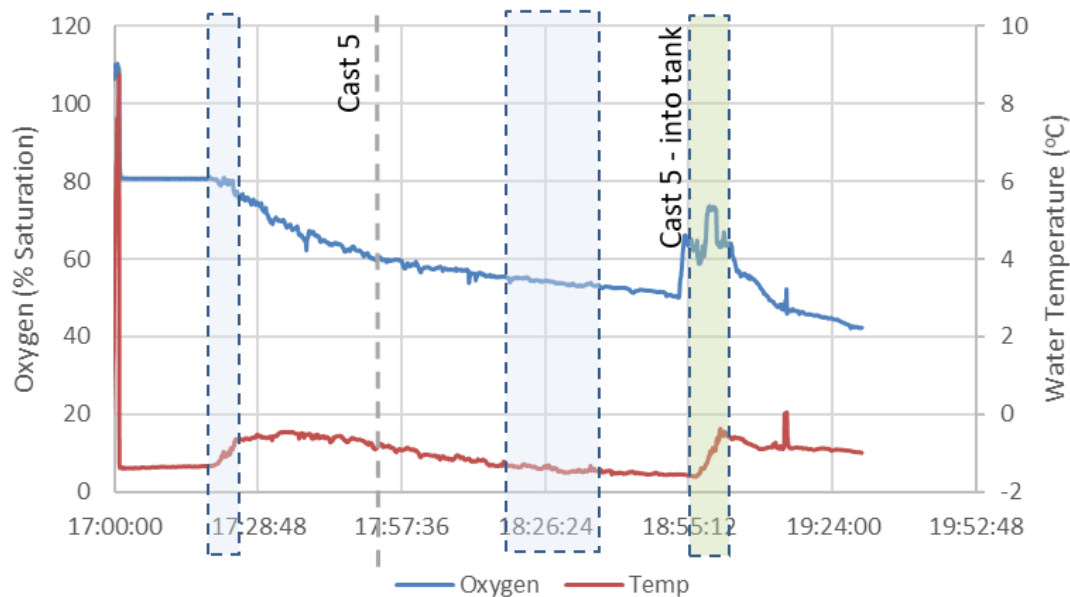
**Figure 5.2.** Temperature (°C) and oxygen concentration (% saturation) in a re-frigerated seawater tank (RSW PORT #2) during and after the additional of catch of cast 4 (and including the addition of catch from cast 5). Periods when samples from the catch of cast 04 are monitored for vitality are shown as blue shaded areas.

ambient temperature of the seawater in which the fish were taken from (~11 °C). Dissolved oxygen decreased in each tank over time: rapidly, following the addition of the catch; but then the depletion rate gradually slowed (figure 5.2).

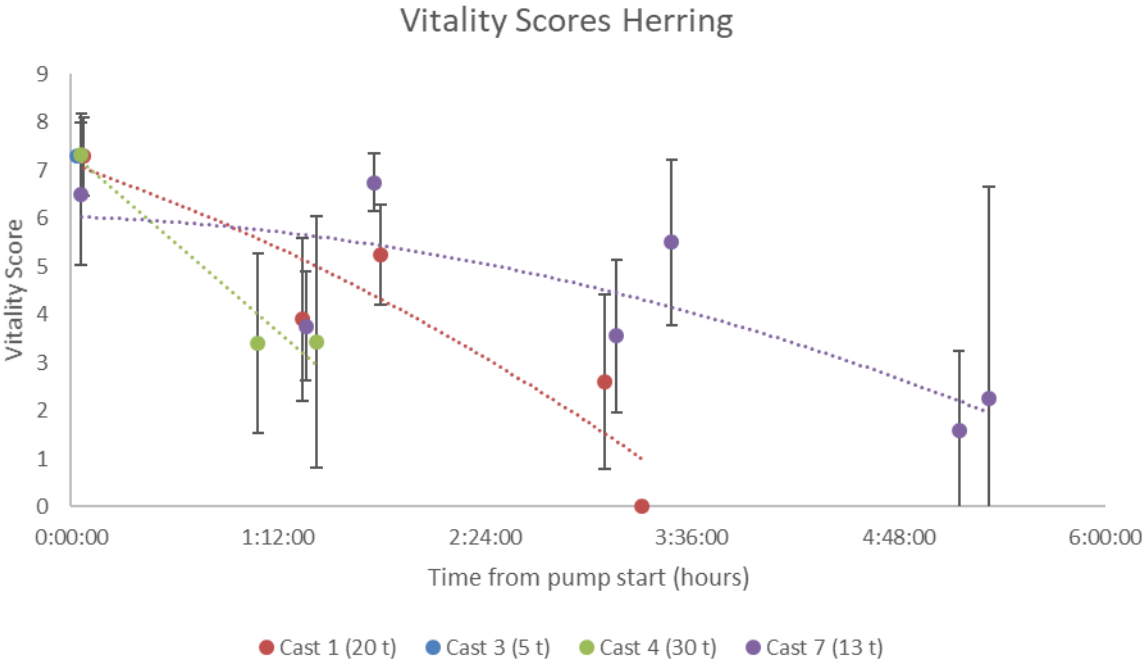
**Figure 5.3.** Vitality scores from sub-samples of herring taken during pumping, and subsequently from the RSW tanks. The rate of decline of the vitality scores appears to be related to the size of the respective catch.

Mean vitality scores generally decreased over time, but some fish remained alive in the RSW tanks for several hours after capture and pumping (figure 5.3). Moreover, preliminary results

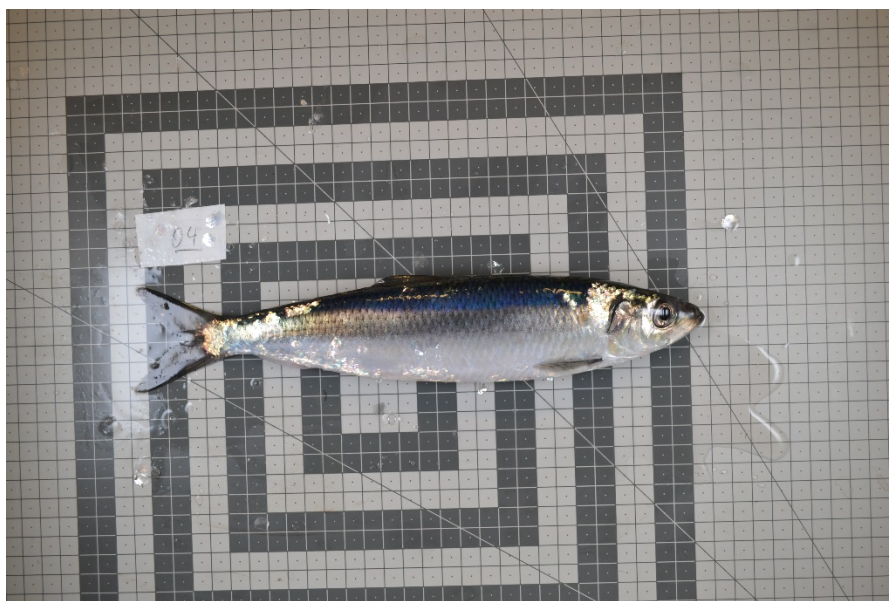
**Figur 6.1.** Silden ble fotografert på begge sider i en fotoboks. Hver fisk var merket og bildene kan kobles mot vitalitetsresultat og lengde-/vektdata.

Det er fortsatt usikkert hva som er årsaken til at sild som blir fanget og trengt i not, dør. Det kan være hudskader og infeksjoner, mangel på oksygen eller en kombinasjon av flere faktorer. Under toktet ble mellom fem og ni sild fra fire kast fotografert i en spesialbygd fotoboks (Figur 6.1). Bildene skal brukes til å måle skjelltap og registrere ytre skader på fisken. Hver fisk er merket og kan kobles til resultat fra vitalitetstest (del 5) og lengde- og vekt målt.
