# CRUISE REPORT 2022106

MAREANO methods cruise: AUV testing (Munin +)

Cruise report 2022106

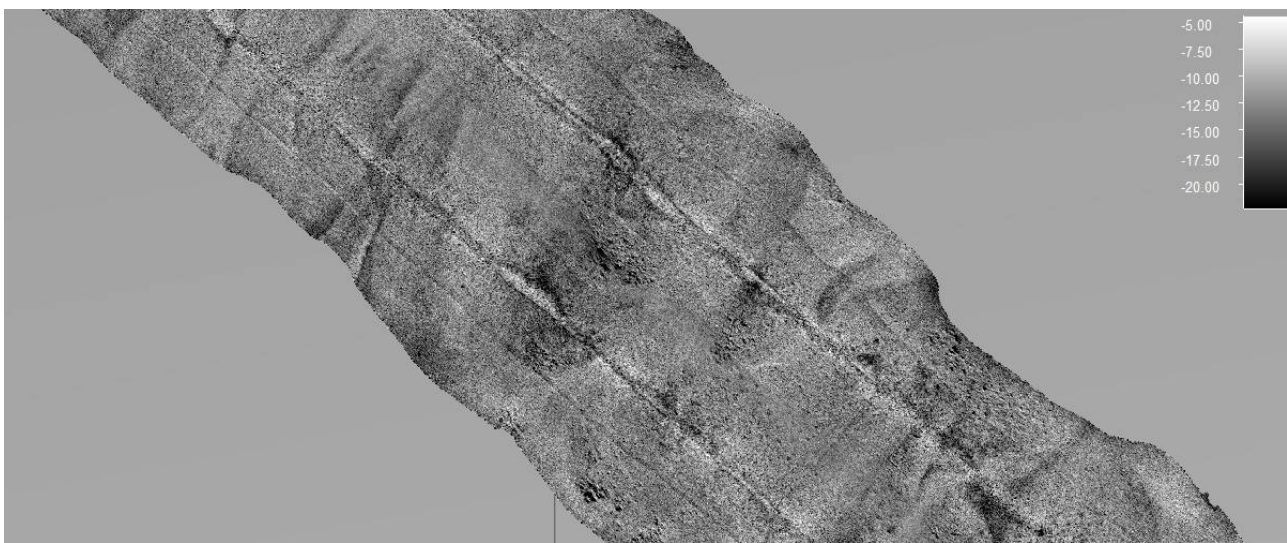
*Example NGU processed backscatter data (FMGT) from AUVMøre\_VL1293 (Mission 55 20220606) showing along track striping (sector problems?)*

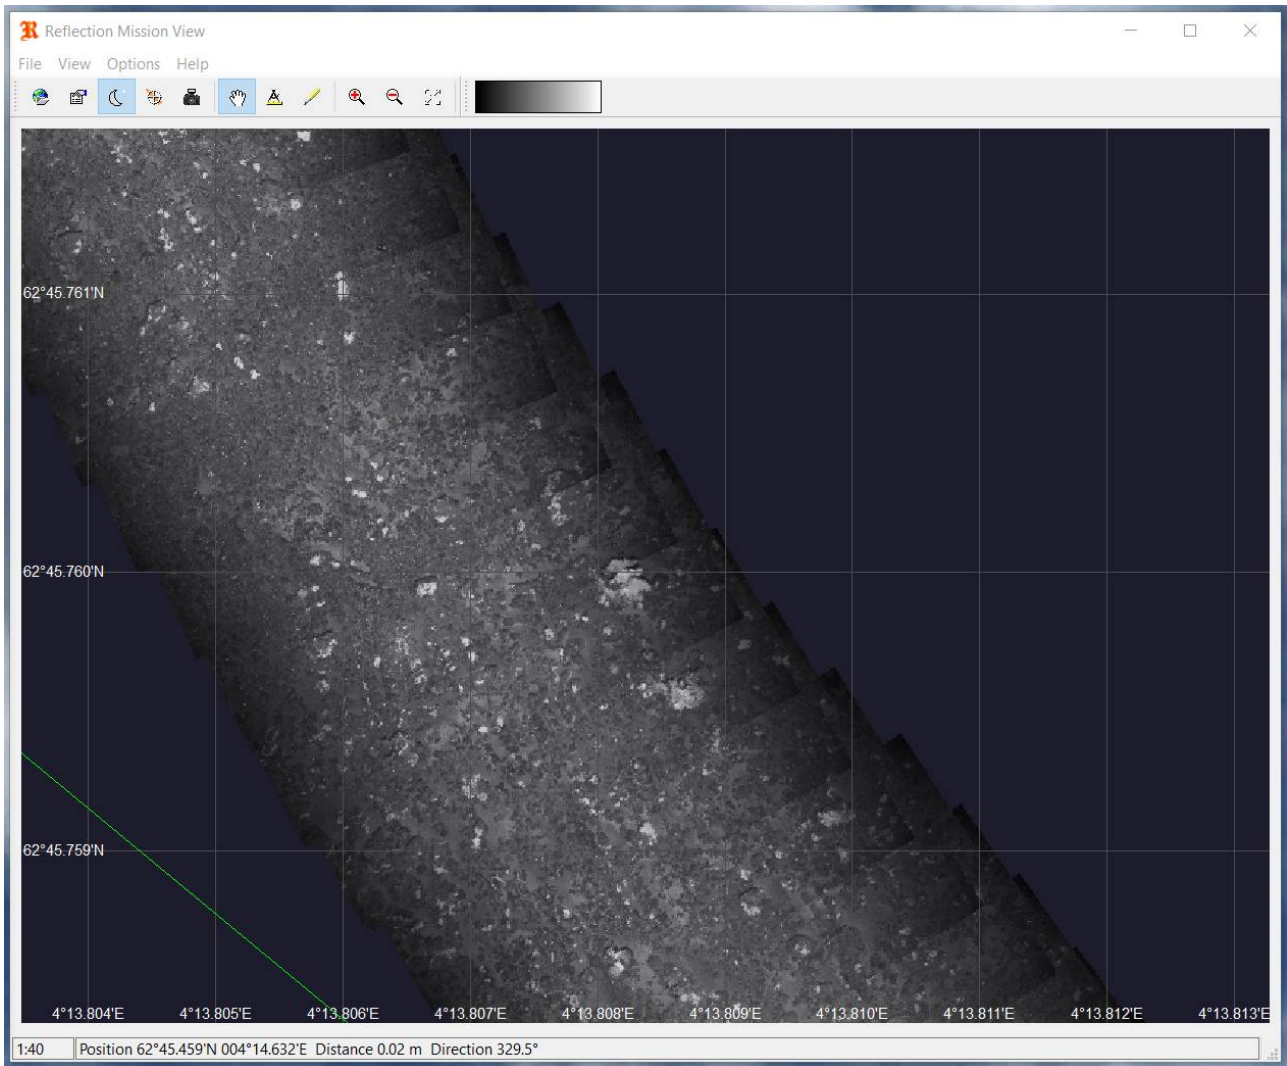
*Example of photo mosaic at 1cm resolution from the 4m altitude downhill run at photoline1293 at AUVmøre, white marks are sponges and corals. Note that averaging must be switched on in "Still Image Mosaic Options" otherwise the image will blur with slightly misaligned images.*

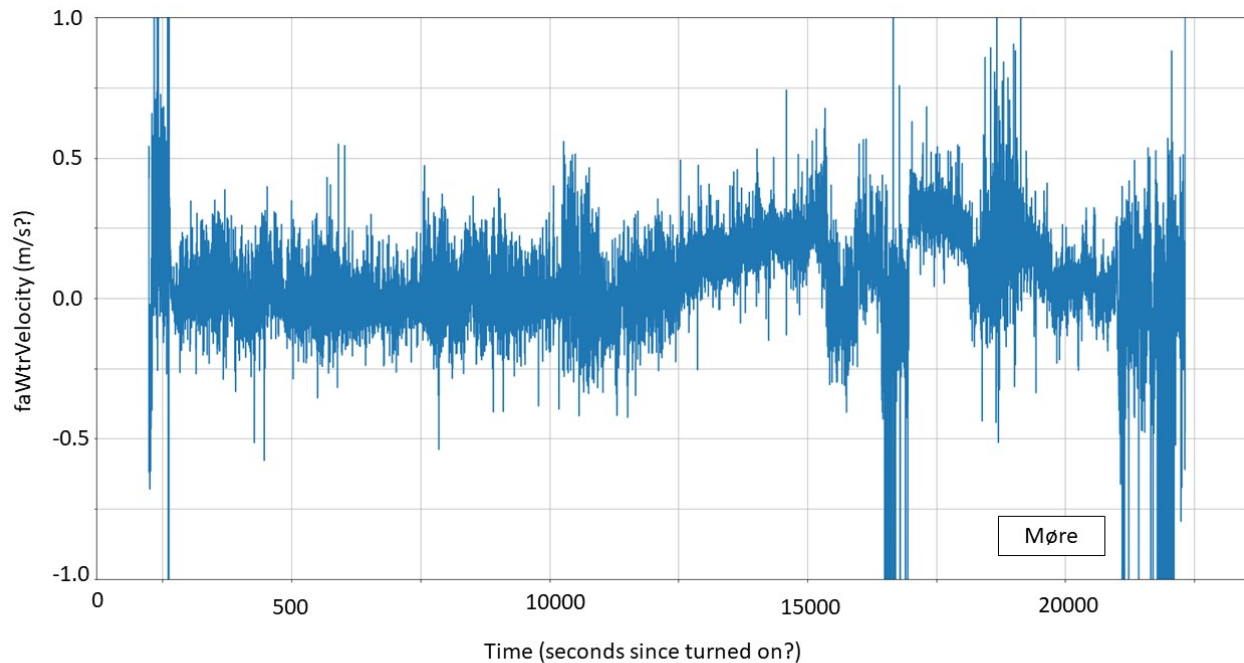
*The parameter faWtrVelocity, assumed to be speed through water in the along-AUV direction, is very similar to faBtmVelocity. Subtracting faBtmVelocity from faWtrVelocity gives the above plot, with residual velocities. The magnitude of the residual current is within expectations from the shelf slope (up to -0.70 m/s).*

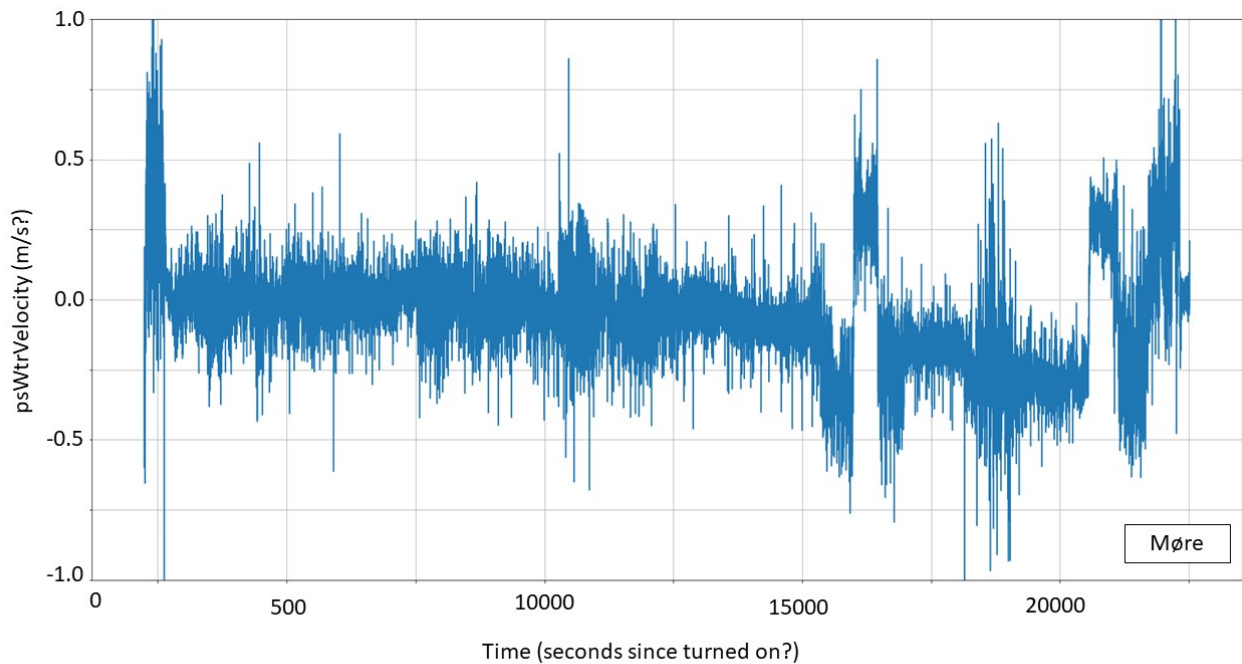
*Above plot is  $psWtrVelocity - psBtmVelocity$  (i.e. residual currents in the cross AUV direction). Again the magnitude of the current is plausible. The AUV descended the slope at an angle, so we would expect the slope current to be split between along- and across-AUV directions.*

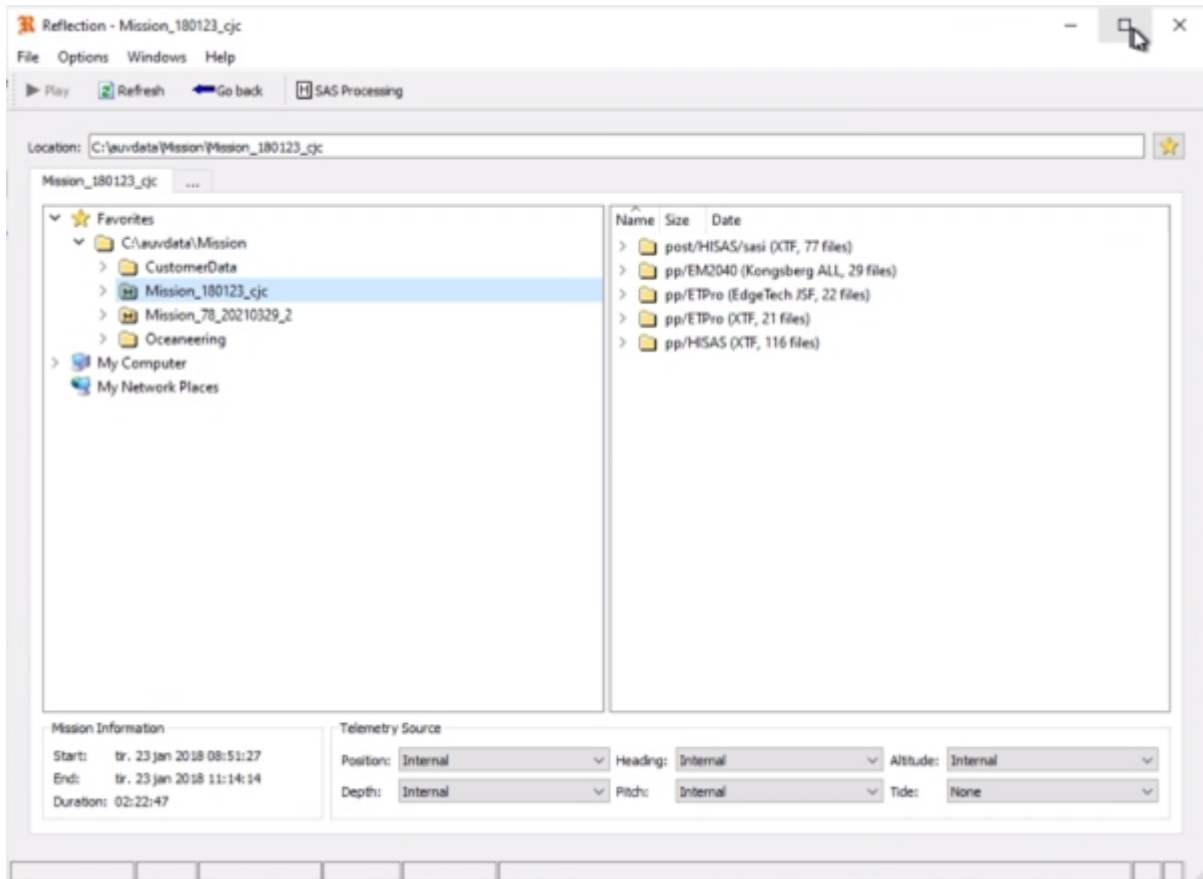
*Screenshot of Reflection's file selection window - the start point when trying to view AUV data*

Within subfolders you can select file to visualise and you can use the dropdown menus at the bottom to modify various options e.g. whether you used processed or unprocessed navigation data. You will then press play to view the data and are automatically shown the right type of viewer for that data.

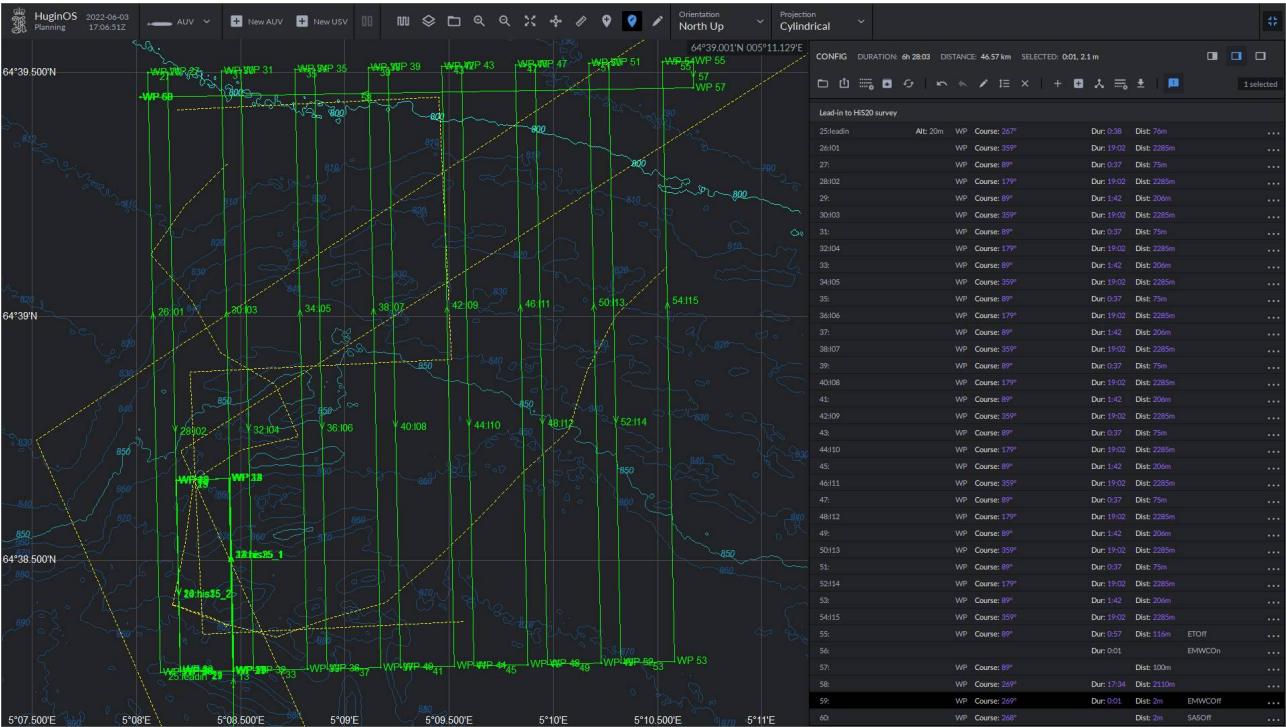
HuginOS screenshot of AUV6 dive plan

In the meantime, we have planned dives at AUV6 and AUVT1. AUV6 now includes 4 heights of HiSAS around a circuit that is ~700m x 300m and mapped over the video line for groundtruthing to provide the heights test that we have not managed to do at the previous 2 sites. Then the rest of the site is in mow-the-lawn pattern for 100% HiSAS coverage with 20m height, followed by a crossline where SBP is switched off and water column MBE is turned on (assuming that it was SBP that interfered with the watercolumn at the test site). This will allow a test of WC over soft bottom. One VL is covered in this area, together with the two 5km template photo dive patterns proposed by Jackson Shields and Oscar Pizarro. An expert-led 5km rout will also be added to the photodive after evaluating the features seen in the acoustics. The acoustic dive should be 6.5hrs long. AUVT1 is planned to follow the turning route that captures multiple video lines and bisects multiple planned boxes/features and climbs several slopes of varying degree to test how the AUV handles this (including in the edge of AUV6 which was reduced in size to accommodate time constraints). The height of acquisition will be decided after the AUV6 results.
